Technical Note N-1258

OSDOC II ENGINEERING TESTS - CORONADO

NAVAL CIVIL ENGINEERING LABORATORY
Port Hueneme, California 93043

The Coronado engineering tests were conducted for purposes of evaluating the equipment capabilities and limitations of the NCEL concept. This concept evaluation included off loading 8'x8'x20' containers from a simulated non-self-sustaining containership and transporting the containers ship-to-shore in a roll-off mode via a pontoon causeway ferry shuttle, and across hardened beaches to a stabilized storage area. Available inventory equipment and techniques were used in these tests, such as a Navy floating YD-type crane, standard NL pontoons, Marine Corps truck/trailers, and Mo-Mat and On-Fast beach hardening. The tests were conducted in two phases: first, in the San Diego Harbor to familiarize the operators with the concept and procedures and second, in the open sea to evaluate the equipment concept. The results of the evaluation demonstrated the feasibility of the concept and the ability of the available inventory equipments to off load containers from ship-to-shore in wave/swell conditions in excess of original estimates for these equipments. Also appare

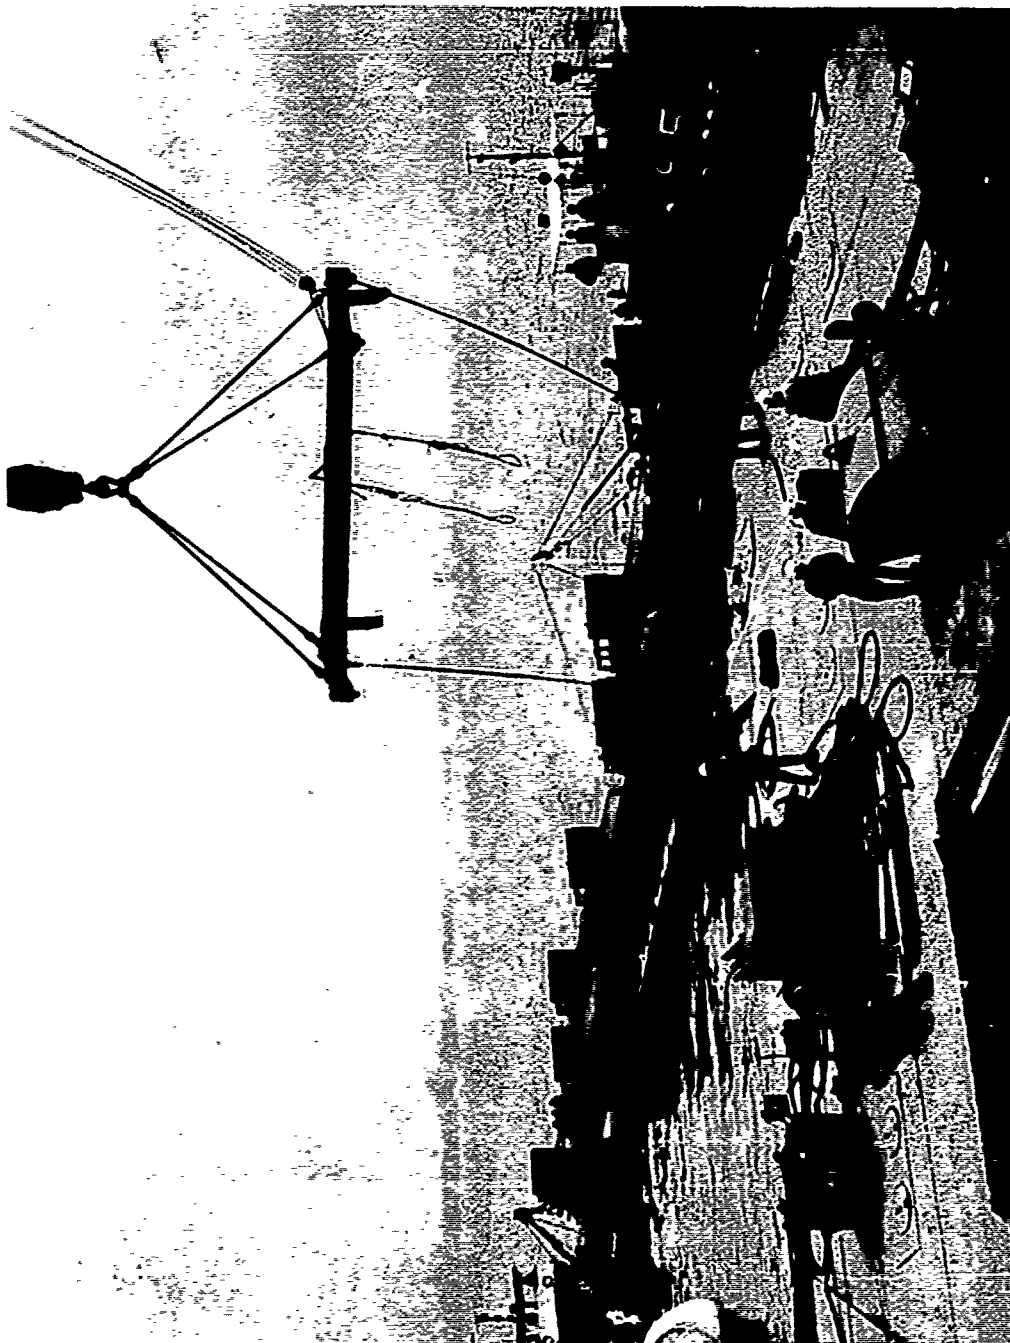
Figure A.12. Seven units of empty trailers were loaded onto a four-section ferry.

The fourteen (14) 24,800-pound containers were backloaded onto the LST on 16 March using the 4-section causeway ferries; the 44,800-pound container was retained ashore for other tests. Two shuttles were made carrying seven (7) loaded truck/trailers on each trip. The average time to move a container directly from the trailer to the LST deck was 3.8 minutes. Figures A.11 and A.12 show this backloading operation.

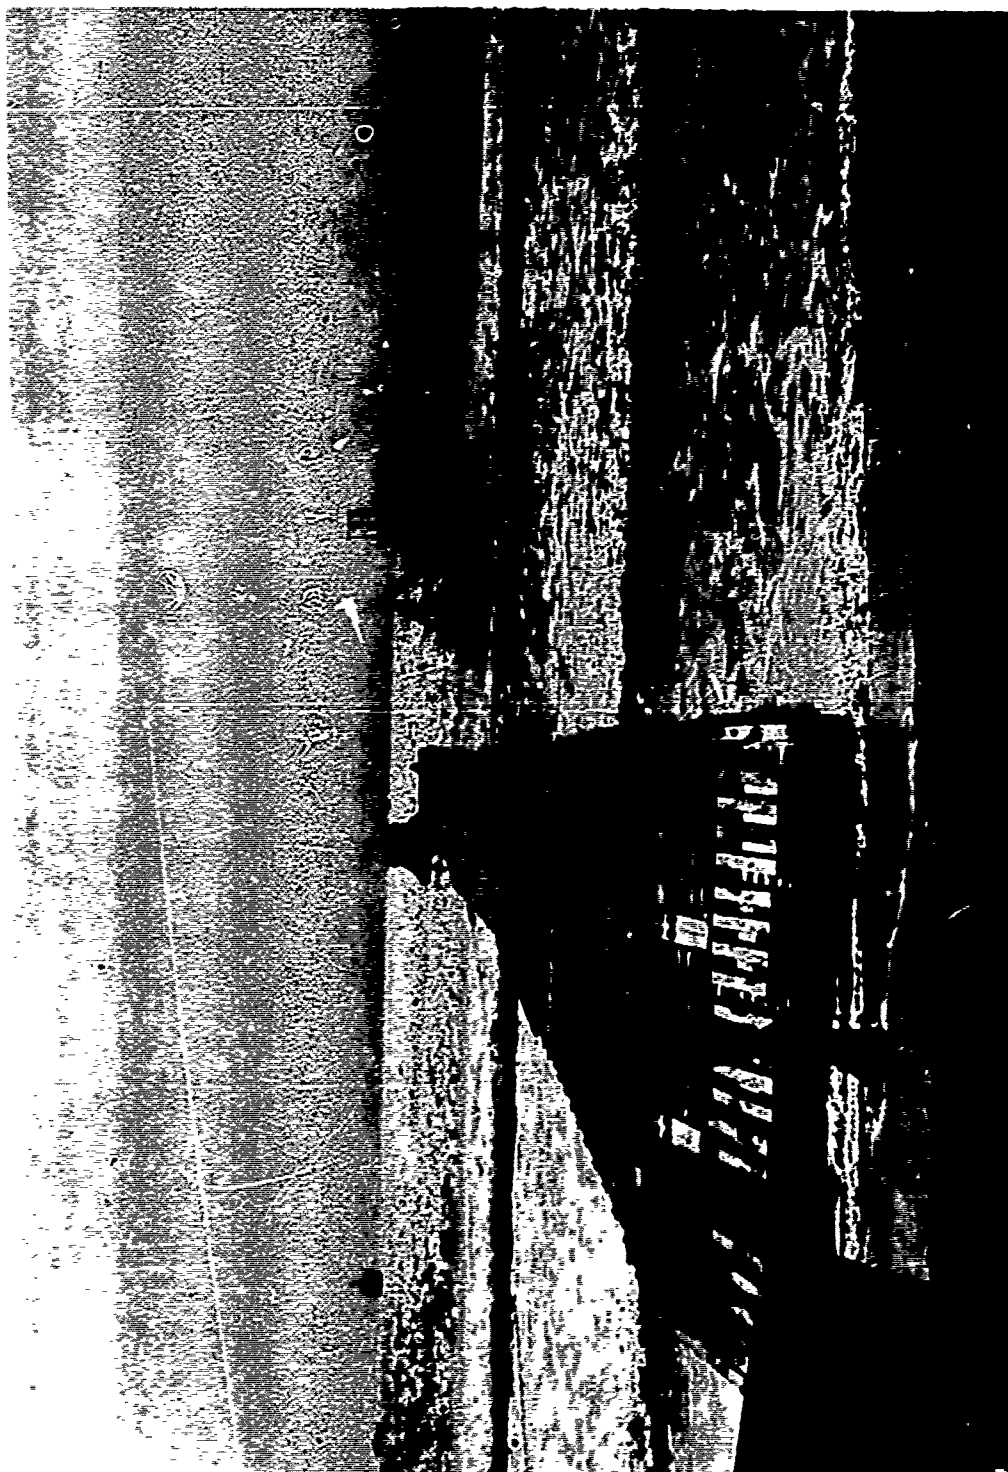
Figure A.13. Warping tug used to install anchors for beached
eight section causeway.

An eight (8) section causeway, Figure A.13, was moored at the open beach landing site on 20 March. Unloading operations began on 21 March with four (4) truck/trailers being loaded onto the 4-section causeway ferry, Figure A.14, and moving to the LST/crane barge area about 2,500 yards offshore. Lines securing the crane barge to the LST and the lines tying the 6x15 barge to the crane barge parted as a result of relative surge motions. The crane barge surge in one direction was observed to be 6-8 feet in 4-6 seconds while no apparent surge motions were observed in the LST or causeway ferries/6x15 barge. Swell heights at ship were 3.0 to 5.0 feet with 12 second period. It was decided to postpone unloading until more adequate lines and fenders were installed.

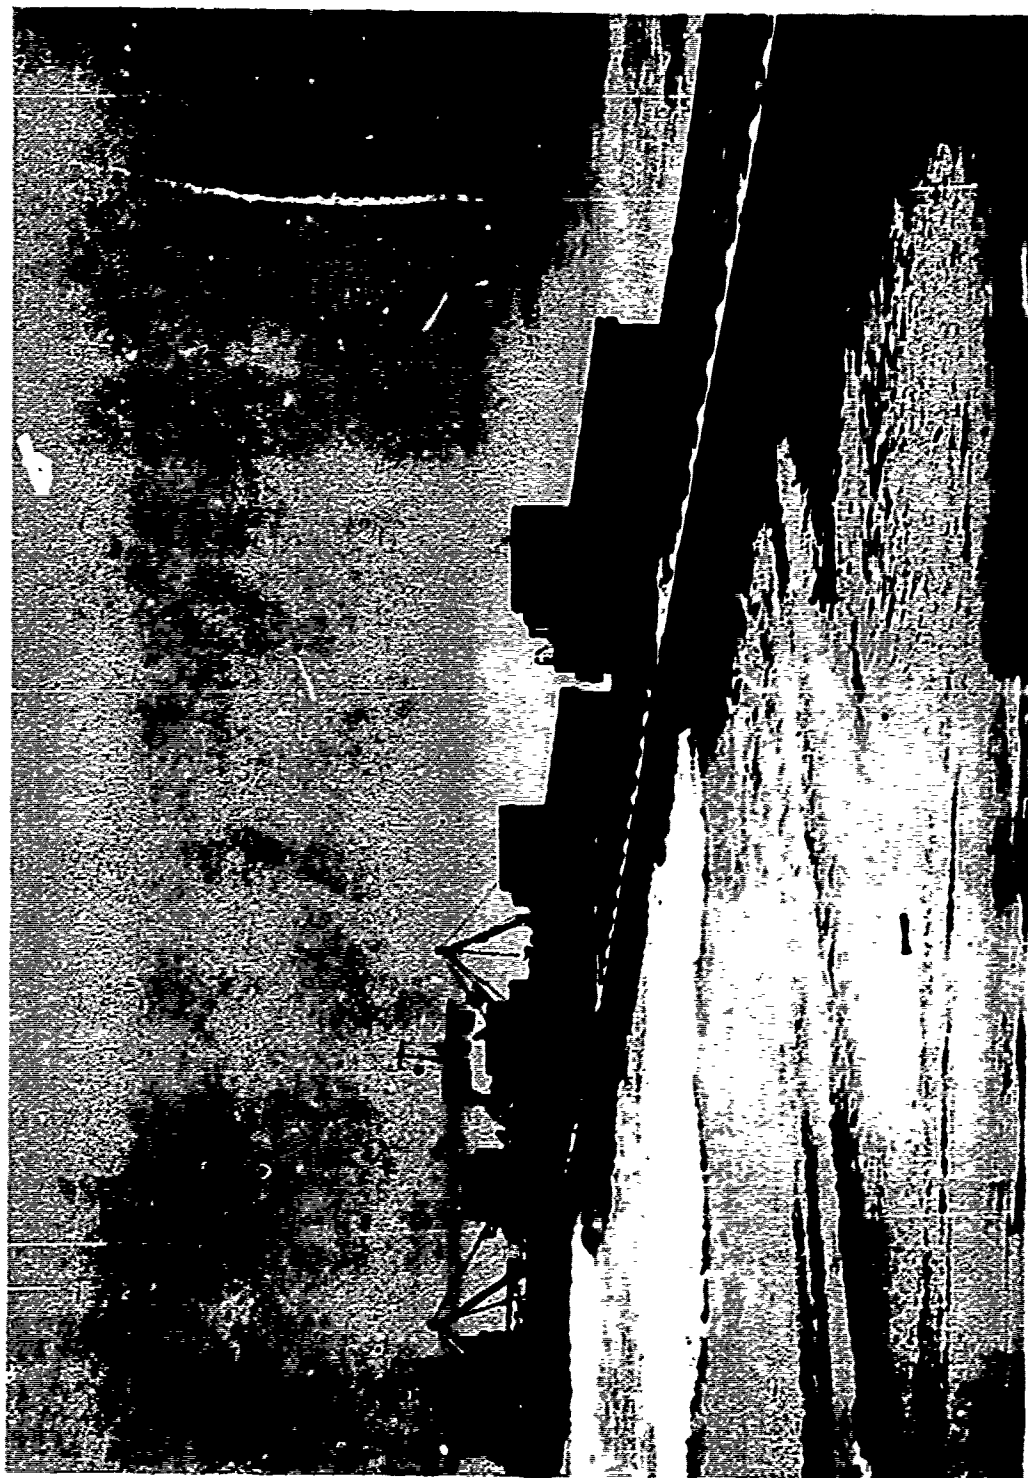
Figure A.14. Driving M52/M127 units onto 4-section ferry.

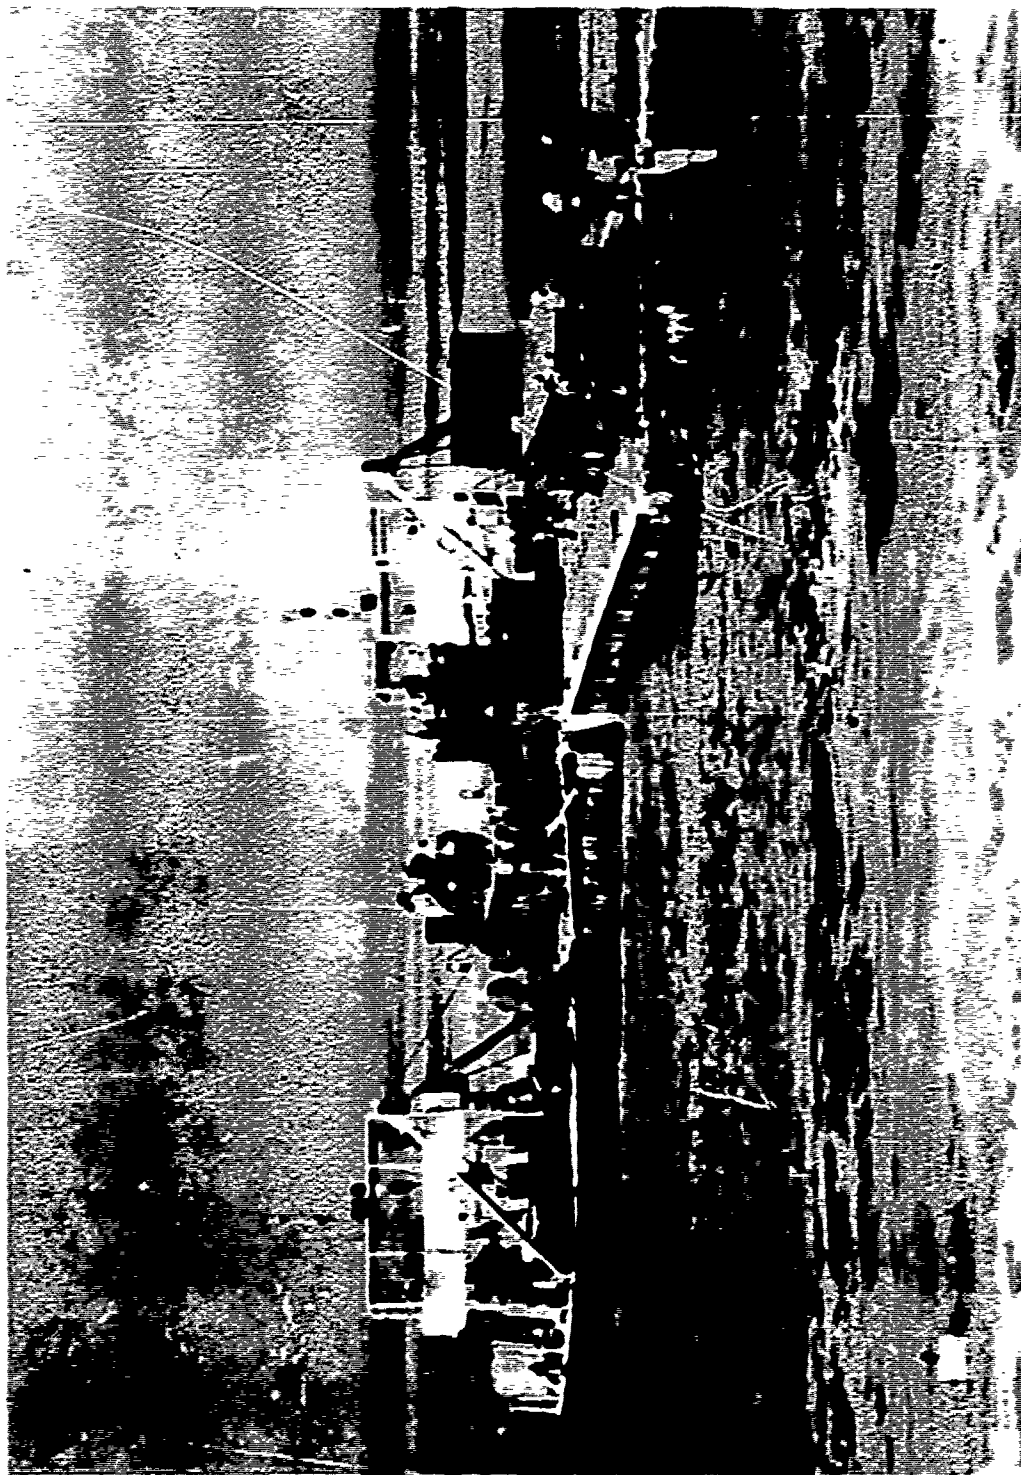
Figure A.20. Driving M52/M127 units across 8-section moored causeway
to 3-section ferry.

During the morning of 23 March, a 3-section ferry was end connected to the 8-section, moored causeway. Waves were 3-5 feet in height. Three empty truck/trailers were driven from the beach, across the 8-section causeway and onto the 3-section ferry. The ferry was moved to the 6x15 barge where the trailers were loaded with 24,800-pound containers. When the 3-section ferry returned to the 8-section, moored causeway, the waves had increased in height to 8-9 feet. (See Section E.1) Initial attempts to end connect the ferry to the causeway were unsuccessful. This end connection operation was terminated because of the danger to personnel. Consequently, no containers were moved ashore across the 8-section, moored causeway. See Figures A.20 and A.21. Average operational times for 22-23 March are listed in Tables A.2 and A.3.

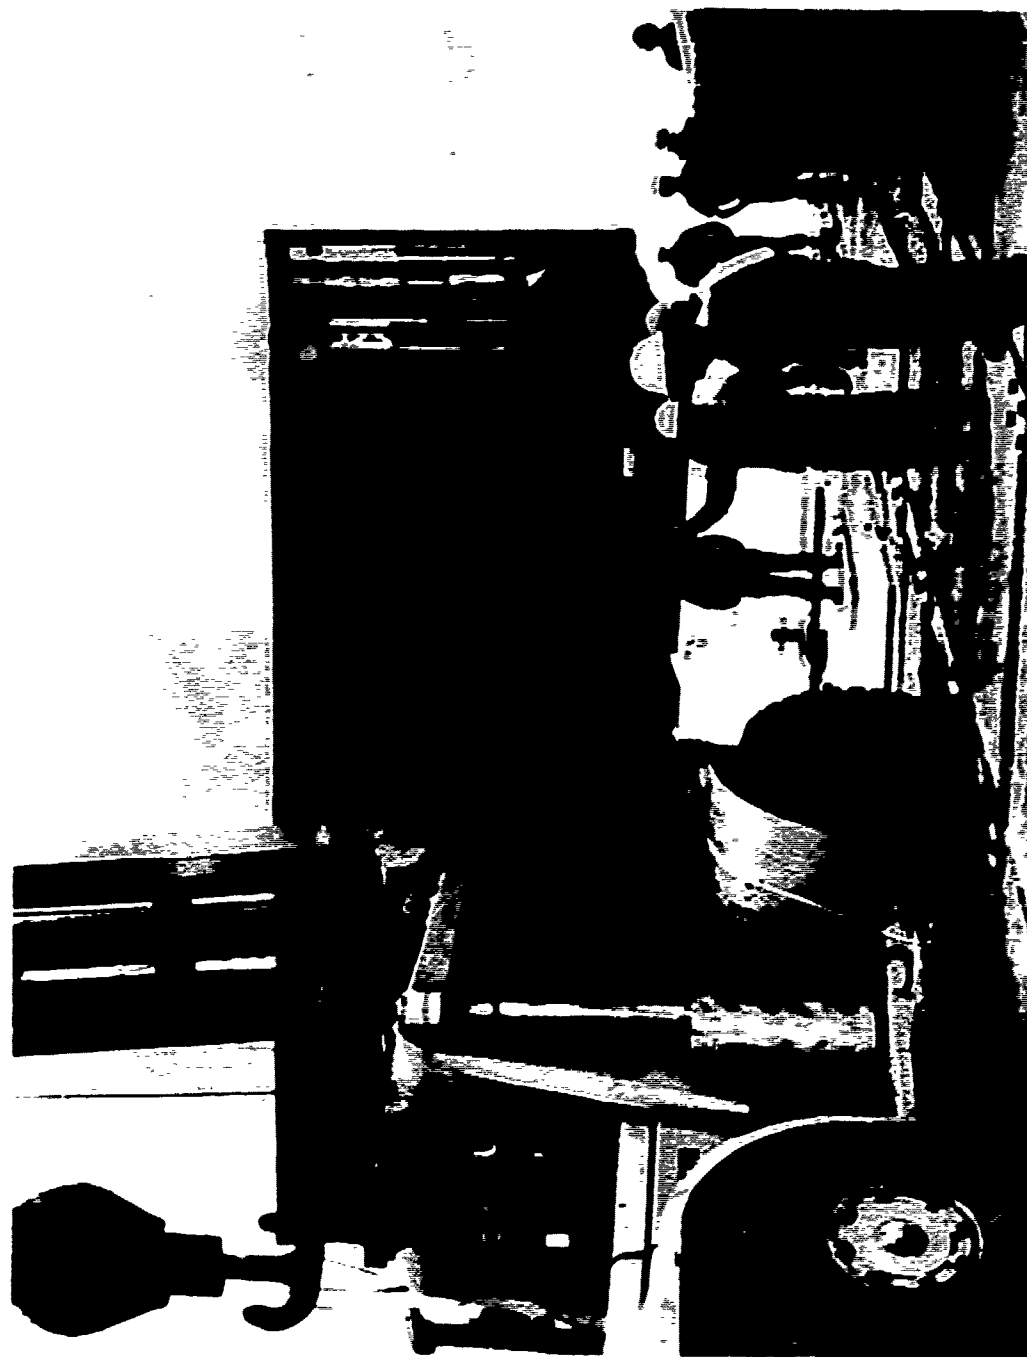
Figure A.22. Front lift loader moving container to trailer.

This container handling equipment was used to lift the containers from the 6x15 barge deck and to position the container on the trailer which was moved from the causeway ferry to the 6x15 barge. See Figures A.22 and A.23. The front lift loader was a Hyster, Model 460B, with a rated lift capacity of 46,000 pounds at 48-inch distance from the face of the forks to center of gravity of the load. The front lift loader weighed 72,000 pounds, was 343 inches long (including 8-foot forks) and was 119 inches wide. This equipment handled the 24,800-pound containers on the forks without difficulty. The equipment lifted the 44,800-pound container and set it on the trailer in the harbor operations, but it was the observer's opinion that this operation would be dangerous in rough water because the rear wheels were carrying practically no load and the loaded container could tilt forward in rough wave action. The tines on the loader, originally 12 feet long, had been shortened to 8 feet for purposes of operational clearances on the 6x15 barge. However, the tines were very thick at their root because of the original 12-foot length and this extra thickness prevented insertion of the tines into some container pockets. Also the tines would bind or hang on the pockets and trailer bed thereby slowing the operation.

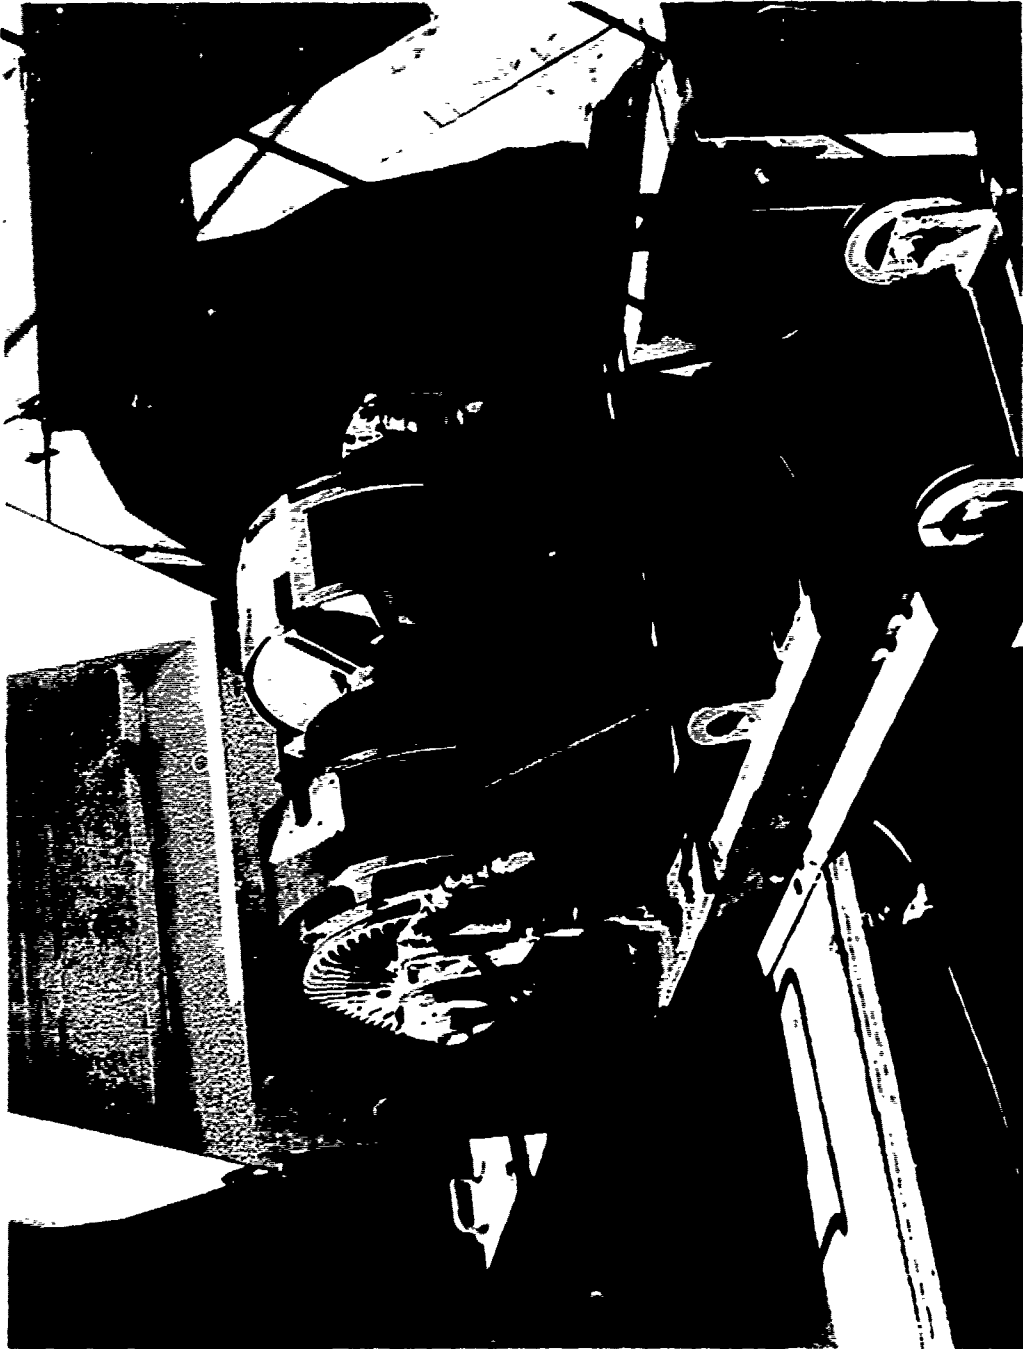
Figure B.2. Powered tagline system on crane.

The power tagline was employed primarily to steady the container or spreader/container during transit between the LST and 6x15 barge. The initial tension setting of 50 pounds proved to be a hindrance to the deck crew manning the manual taglines. It was difficult for the crew to overcome the pull of the tagline on the spreader particularly during final positioning of the spreader over a container, into the cell or when positioning the container on the deck of the 6x15 barge. It was necessary to adjust the line tension several times during the operation until a tension of about 15 to 25 pounds was established. The power tagline was deactivated when final positioning the spreader or container was required. It was noted that the electric motor overheated during prolonged use under maximum tension. The crane/powered tagline combination is pictured in Figure B.3.

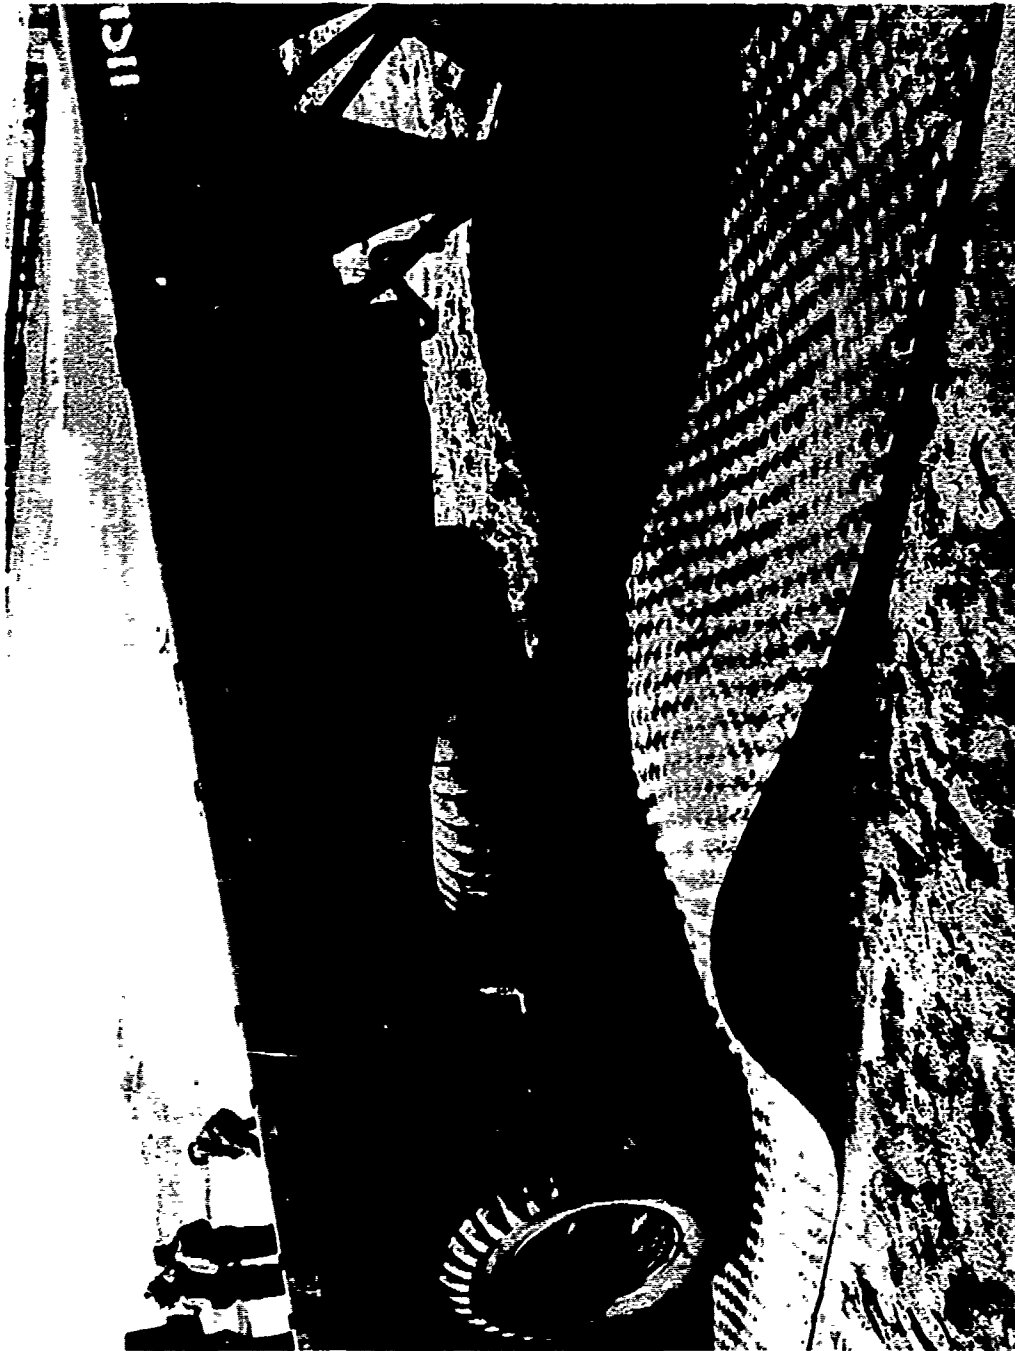
Figure C.2. Wave developed by trailer wheels on Mo-Mat.

The truck/trailers (M52/M127) units were empty while driving down the beach slope and carried the 24,800-pound containers up the beach slope. Sometimes Mo-Mat developed a wave between the trucks' front and rear wheels, but it flattened out without damage. This material operated satisfactorily during the tests. See Figures C.1 and C.2.

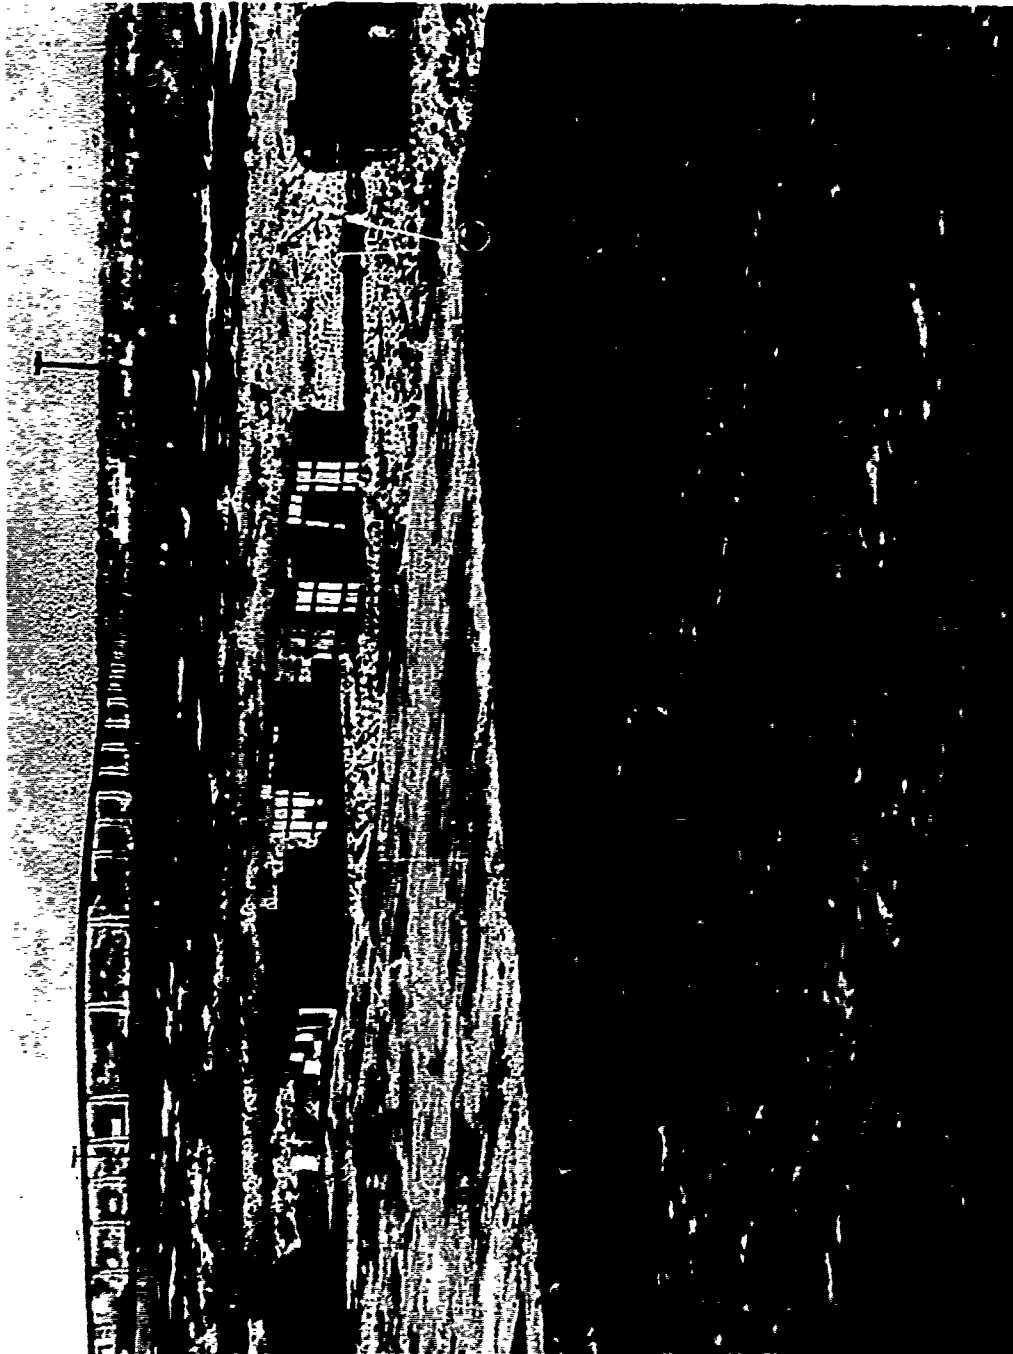
Figure C.6. On-Fast hardstand installed adjacent to AM-2 mat.

No damage attributable to traffic occurred on the 100 foot by 100 foot On-Fast pad. It was expected that some shearing action of the On-Fast might have occurred where the On-Fast overlapped the AM-2 matting; however, such was not the case.

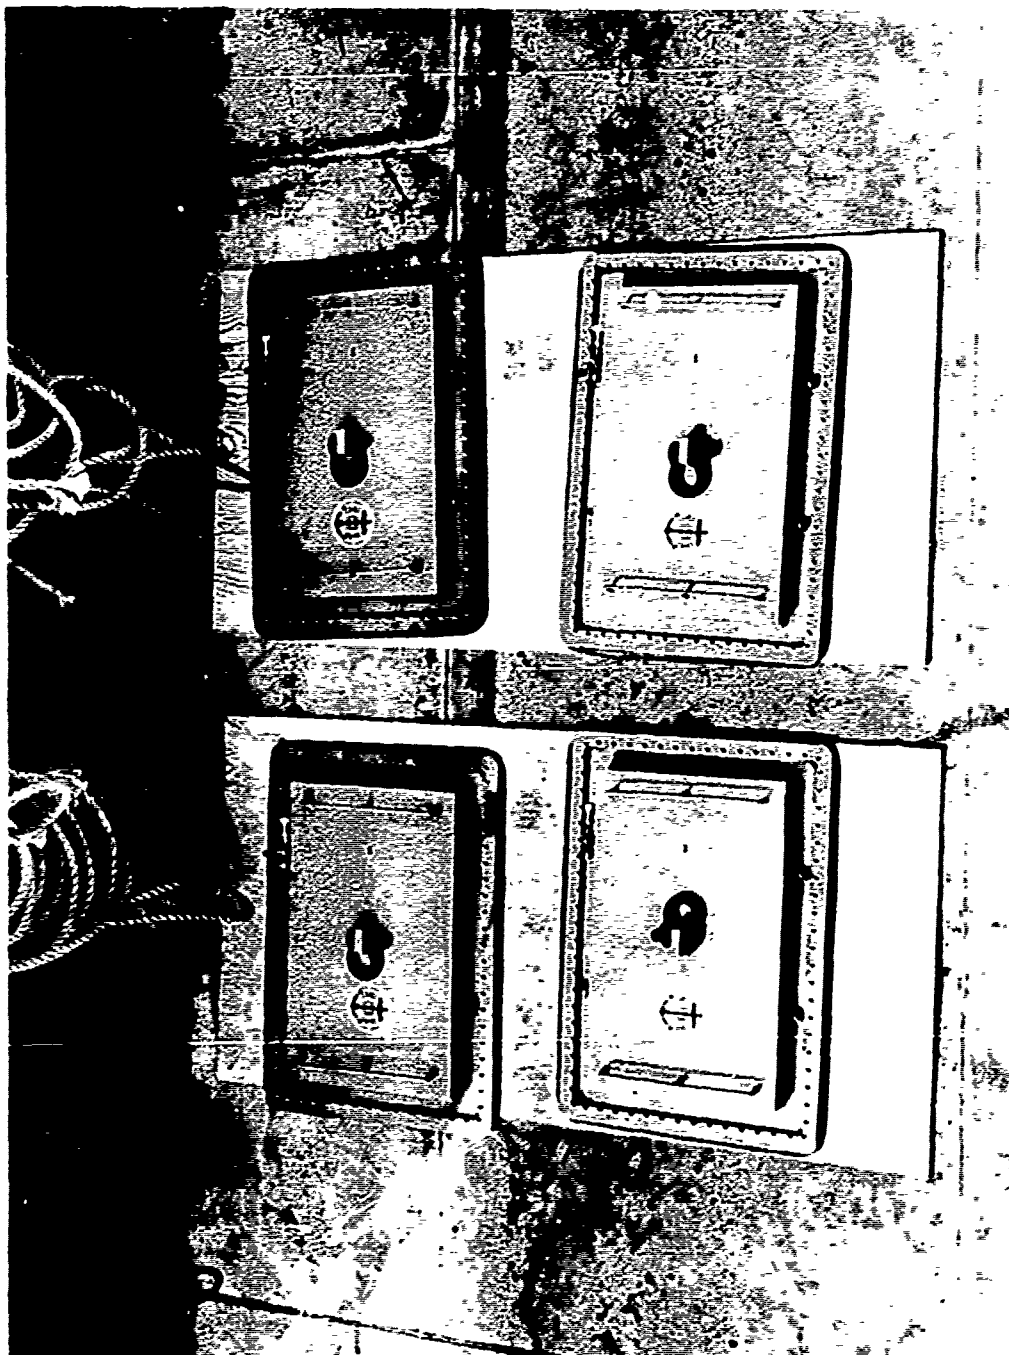
Figure D.6. 3'x4' vacuum pads intended for tying barge to LST.

The plan was to use five of the 20,000-pound capacity units to hold the 6x15 barge. But on-site changes in operational procedures coupled with electrical problems associated with the ship's power supply precluded testing the vacuum pad concept. The units are pictured in Figures D.5 and D.6.
